Subject: **Recall for Genuine Innovations Second Wind MTB and Wrench Force Two Shot**
Importance: **High**

- **Genuine Innovations Second Wind MTB:** Part Numbers - 2525, 2525-0, and 3519
- **Wrench Force Two Shot:** Part Numbers - 84995, 84995-1, and 80383

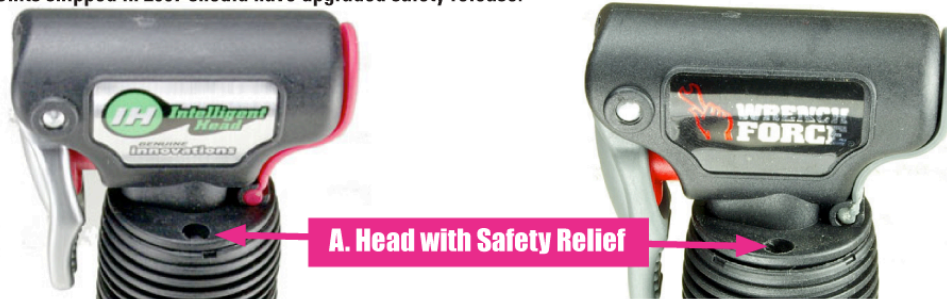
1) To locate the Safety Relief Feature, look at the head on a Genuine Innovations Second Wind MTB or Wrench Force Two Shot with lever to the left side. You will find the Safety Relief Feature by looking just below the sticker, at the flat surface that is at a right angle coming toward you. On this surface, you will see a small 3/16" in (4.75 mm) hole.

- a. **HEAD WITH SAFETY RELIEF** - If you have the Safety Relief Feature, the device has already been upgraded and is safe for use. Units shipped in 2007 should have upgraded safety release.

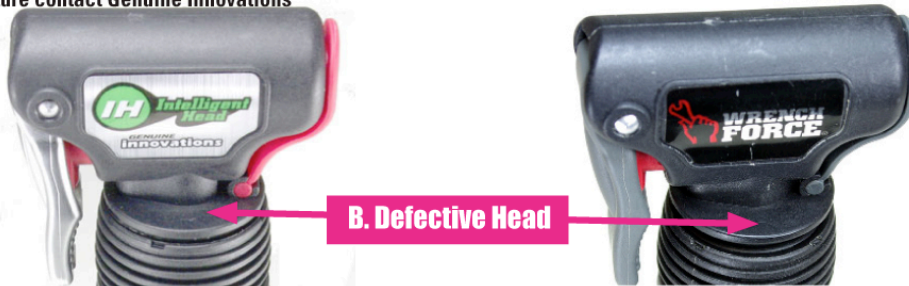
The unit can shatter while under pressure when inflating tires. This poses a risk of injuries, such as bruising, lacerations, and ringing in the ears.

- b. **DEFECTIVE HEAD** - If the Head on your Genuine Innovations Second Wind MTB or Wrench Force Two Shot does not have the Safety Relief Feature contact Genuine Innovations

1. Stop using your Second Wind MTB or Wrench Force Two Shot immediately.
2. Please complete the Return Instructions on the back of the Safety Recall Notification from L.L.Bean.
3. Place the pump head, along with the completed return form, in the enclosed shipping envelope and attach the pink mailing label.
4. Mail via US postal service.
5. When we receive the defective head, we will promptly send you a Repair kit that contains a replacement head that has been upgraded with the Safety Relief Feature.
